Phase III ESA & Hazardous
Materials Assessment
Former Consolidated Rambler
Copper Mine, Baie Verte, NL

NEWFOUNDLAND AND LABRADOR
DEPARTMENT OF NATURAL
RESOURCES - MINERAL
DEVELOPMENT DIVISION

REPORT NO. 1028976

February 1, 2008

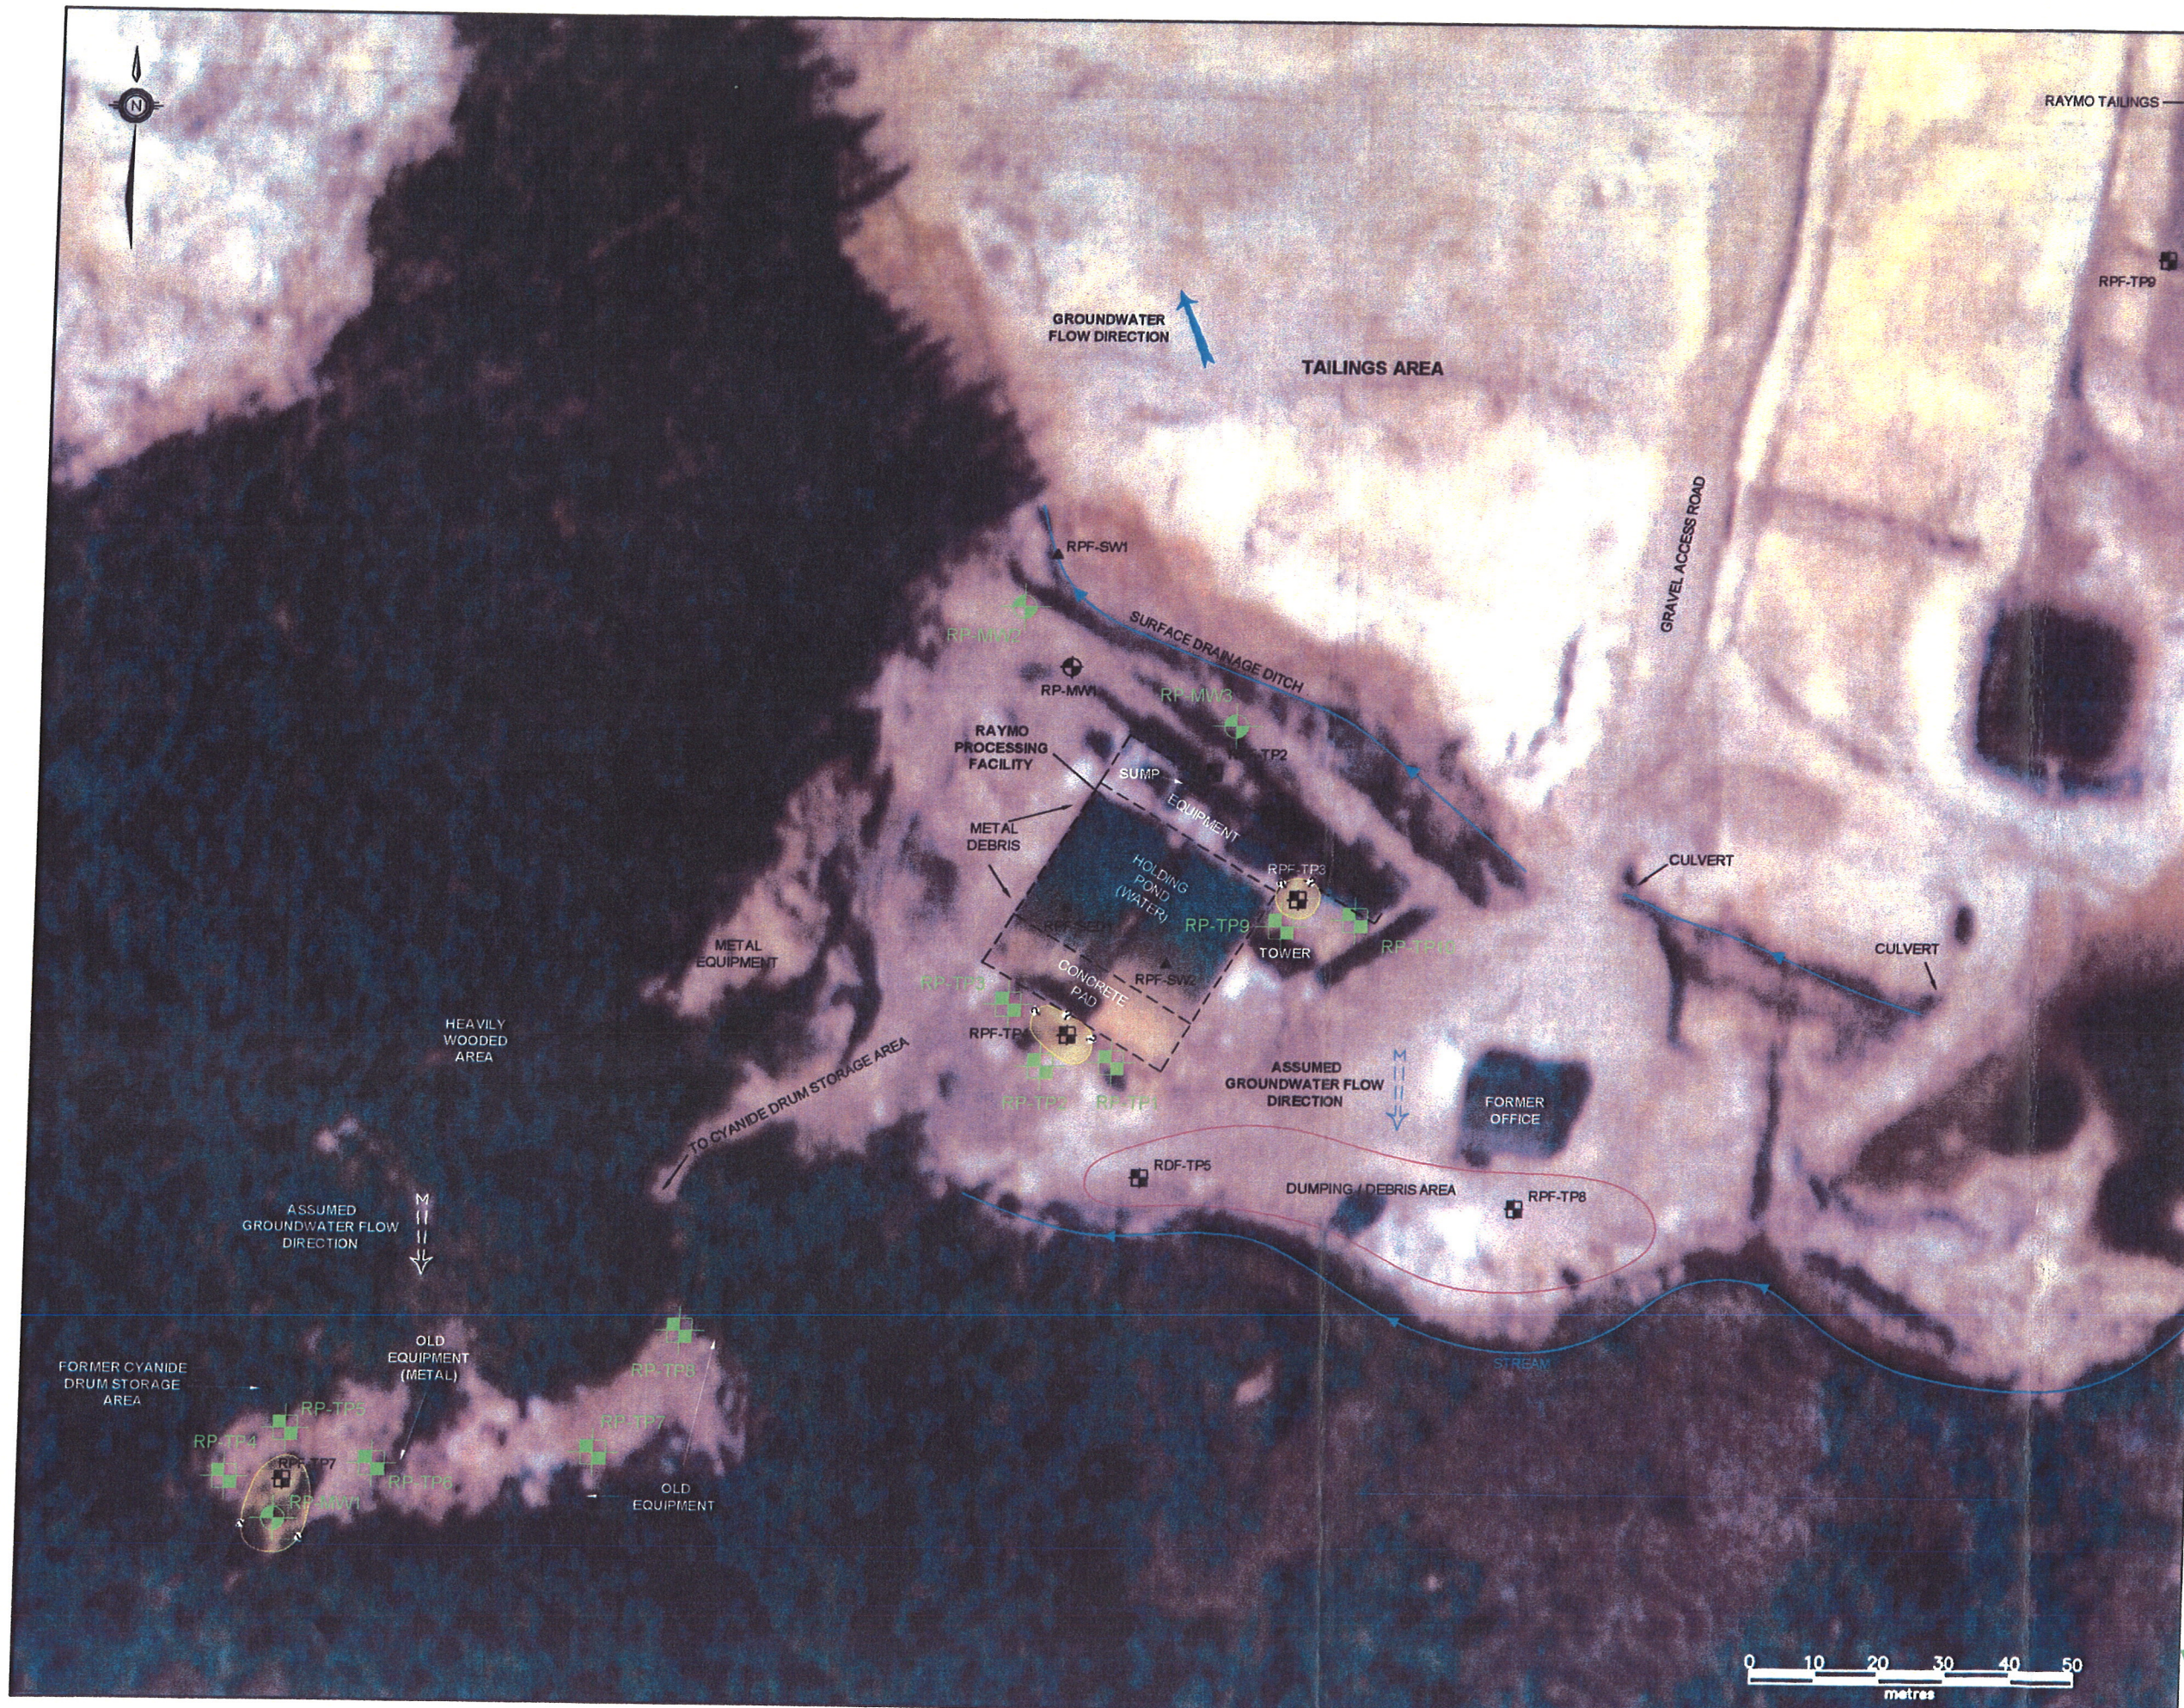
SCALE	1:1000	DATE	DEC. 13, 2007
DRAWN BY:	N.M.	CHECKED BY:	
EDITED BY:	-	REV. No.	0
DRAWING No:	1028976-EE-04		
CAD FILE:	1028976-EE-27.DWG

5. The estimated extent of total cyanide in soil exceeding the CCME criteria for free cyanide in soil on an industrial site in the vicinity of monitor well RP-MW1 and former test pit RPF-TP7 is approximately 150 m². Based on analytical evidence of impacts and the noted depth to bedrock (0.8 m) in this area, it is expected that approximately 120 m³ of impacted soil in the vicinity of monitor well RP-MW1 and former test pit RPF-TP7, exceeds the CCME criteria for free cyanide in soil on an industrial site. Most of the impacted soils in this area are readily accessible for removal, if required. Additional delineation would be required to refine the impacted soil estimates. Further, analysis of specific cyanide species would be required to determine the actual extent of free cyanide impacts in soil in this area. It is possible that the extent of free cyanide impacts in soil in this area is less than that determined for total cyanide.

7. The estimated extent of total cyanide in soil exceeding the CCME criteria for free cyanide in soil on an industrial site in the vicinity of former test pit RPF-TP4, located in the former processing facility area, is approximately 50 m². Based on analytical evidence of impacts and the noted depth to bedrock (0.6 m) in this area, it is expected that approximately 30 m³ of impacted soil in the vicinity of former test pit RPF-TP4, exceeds the CCME criteria for free cyanide in soil on an industrial site. Most of the impacted soils in this area are readily accessible for removal, if required. Additional delineation would be required to refine the impacted soil estimates. Further, analysis of specific cyanide species would be required to determine the actual extent of free cyanide impacts in soil in this area. It is possible that the extent of free cyanide impacts in soil in this area is less than that determined for total cyanide.

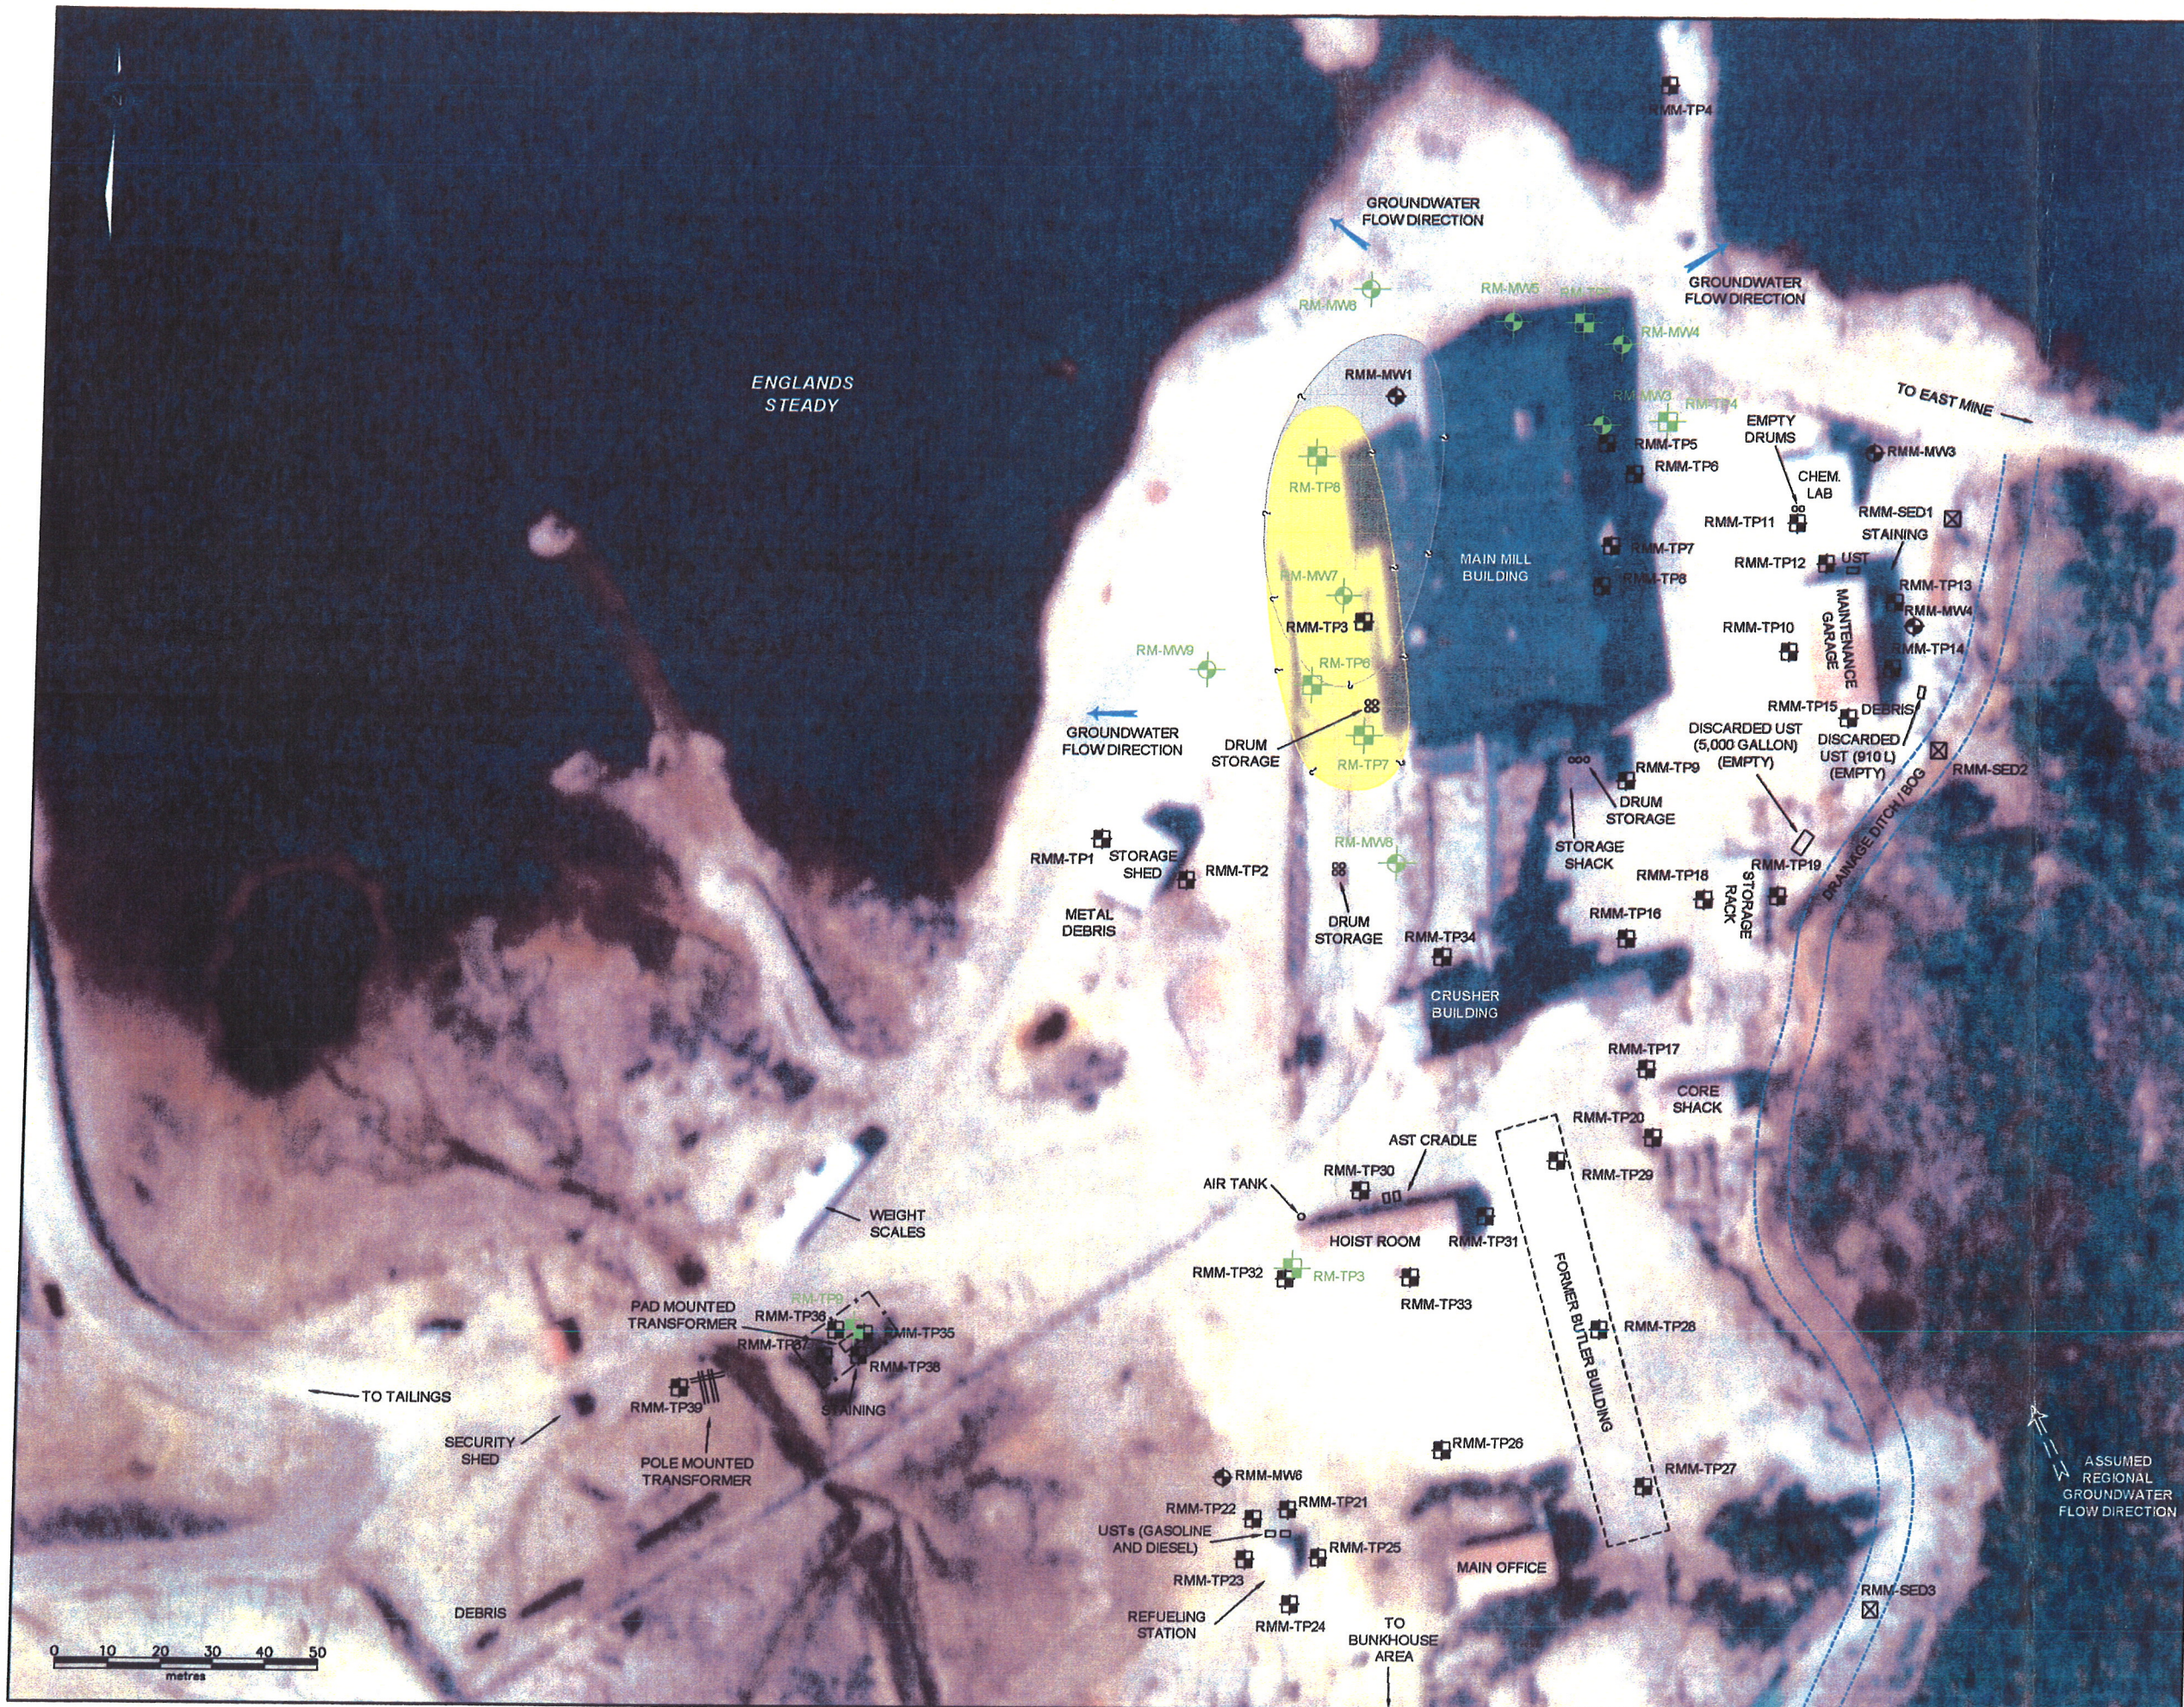
9. The estimated extent of total cyanide in soil exceeding the CCME criteria for free cyanide in soil on an industrial site in the vicinity of test pits RM-TP6, RM-TP7, and RM-TP8, and former test pit RMM-TP3, located along the west side of the mill building, is approximately 2,000 m². Based on analytical evidence of impacts and the noted depth to bedrock in this area, it is expected that approximately 1,400 m³ of impacted soil in the vicinity of test pits RM-TP6, RM-TP7, and RM-TP8, and former test pit RMM-TP3, exceeds the CCME criteria for free cyanide in soil on an industrial site. Analytical evidence indicates total cyanide impacts are present from surface to the base of the overburden layer in this area, which ranges in depth from 0.4 m to 1.8 m. An average depth of 0.7 m was assumed to estimate the impacted soil volume for this area. Most of the impacted soils in this area are readily accessible for removal, if required. Limited evaluation of cyanide impacts in soil has been carried out the vicinity of test pits RM-TP6, RM-TP7, and RM-TP8, and former test pit RMM-TP3, and the actual impacted area may be smaller

10. The estimated extent of total cyanide in soil exceeding the CCME criteria for free cyanide in soil on an industrial site in the vicinity of monitor well RM-MW5, located along the north side of the main mill building is approximately 100 m². Based on analytical evidence of impacts and the noted depth to bedrock in this area, it is expected that approximately 100 m³ of impacted soil in the vicinity of monitor well RM-MW5 exceeds the CCME criteria for free cyanide in soil on an industrial site. Vertical delineation of total cyanide impacts in soil have not been carried out in this area, and it is assumed that total cyanide impacts are present in the upper 1 m of soil in this area. Most of the impacted soils in this area are readily accessible for removal, if required. Limited evaluation of cyanide impacts in soil has been carried out the vicinity of monitor well RM-MW5, and the actual impacted area may be smaller or larger than the estimated area. Additional delineation would be required to refine the impacted soil estimates. Further, analysis of specific cyanide species would be required to determine the actual extent of free cyanide impacts in soil in this area. It is possible that the extent of free cyanide impacts in soil in this area is less than that determined for total cyanide.
